**PRELIMINARY ASSESSMENT/
VISUAL SITE INSPECTION**

**ZEHRCO PLASTICS, INC.
(FORMERLY ROCKWELL INTERNATIONAL -
PLASTICS DIVISION)
ASHTABULA, OHIO
OHD 064 098 262**

FINAL REPORT

Work Assignment No.	:	R05032
EPA Region	:	5
Site No.	:	OHD 064 098 262
Date Prepared	:	March 11, 1993
Contract No.	:	68-W9-0006
PRC No.	:	309-R05032OH35
Prepared by	:	PRC Environmental Management, Inc. (Mary Joyce Freibert)
Contractor Project Manager	:	Shin Ahn
Telephone No.	:	(312) 856-8700
EPA Work Assignment Manager	:	Kevin Pierard
Telephone No.	:	(312) 886-4448

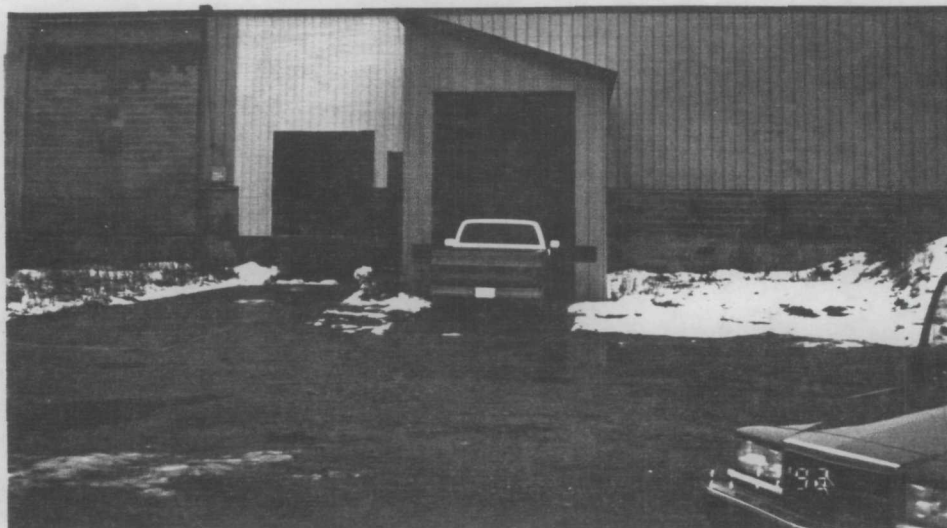
Photograph No. 1

Observations:	The unit contained no hazardous waste during the VSI. The soils in the area were covered with snow; therefore, it is not known if the soil was stained or if the vegetation in the area was stressed. PRC noted no evidence of release (see Photograph No. 1).

Recommendations: PRC recommends that the facility should initiate RCRA closure activities.

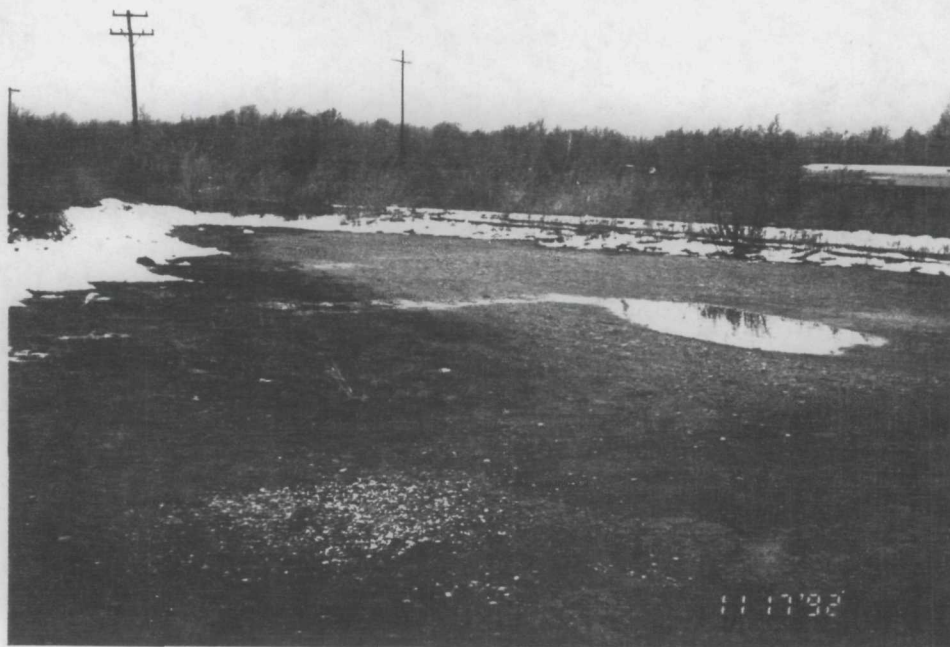
Photograph No. 2

Observations: The unit contained no hazardous waste during the VSI. The area had some dark stains and stressed vegetation in the area (see Photograph No. 2).

Recommendations: PRC recommends that the facility should initiate RCRA closure activities.

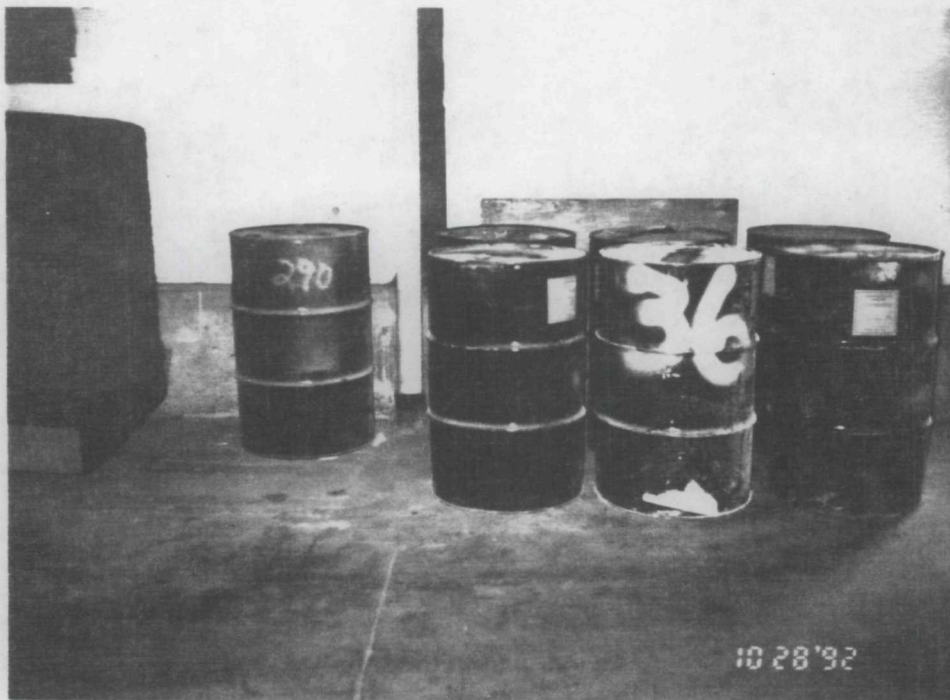
Photograph No. 3
 Orientation: South
 Description: CSA No. 1 located on a concrete floor with no visible cracks

Location: SWMU 3
 Date: 10/28/92

Recommendations: PRC recommends no further action for this SWMU at this time.

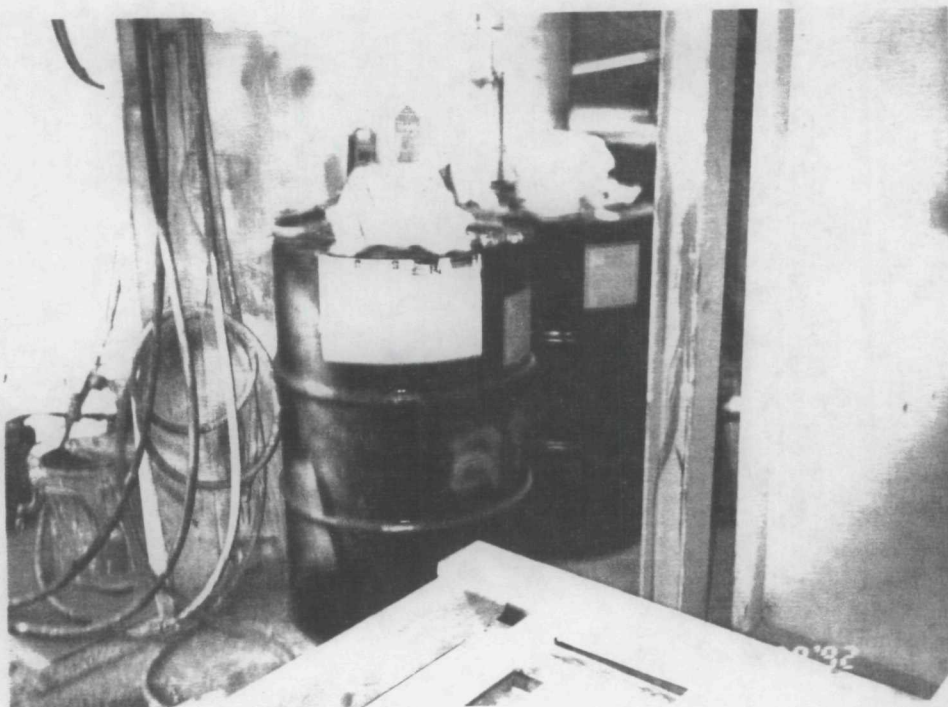
Photograph No. 4
 Orientation: East
 Description: CSA No. 2 located on a concrete floor with no visible cracks

Date of Closure:	This unit is active.
Wastes Managed:	This unit manages spent solvents (F002) from the paint booth. The waste is transported to Chemical Solvents, Inc., in Cleveland, Ohio, for reclamation and disposal.
Release Controls:	This unit is located indoors on a concrete floor. No floor drains were visible during the VSI.
History of Documented Releases:	No releases from this unit have been documented.
Observations:	The unit contained two 55-gallon steel drums of spent solvents (F002) during the VSI. No cracks in the concrete floor or visible evidence of spills were observed (see Photograph No. 4).

Location: SWMU 4
 Date: 10/28/92

Recommendations: PRC recommends no further action for this SWMU at this time.

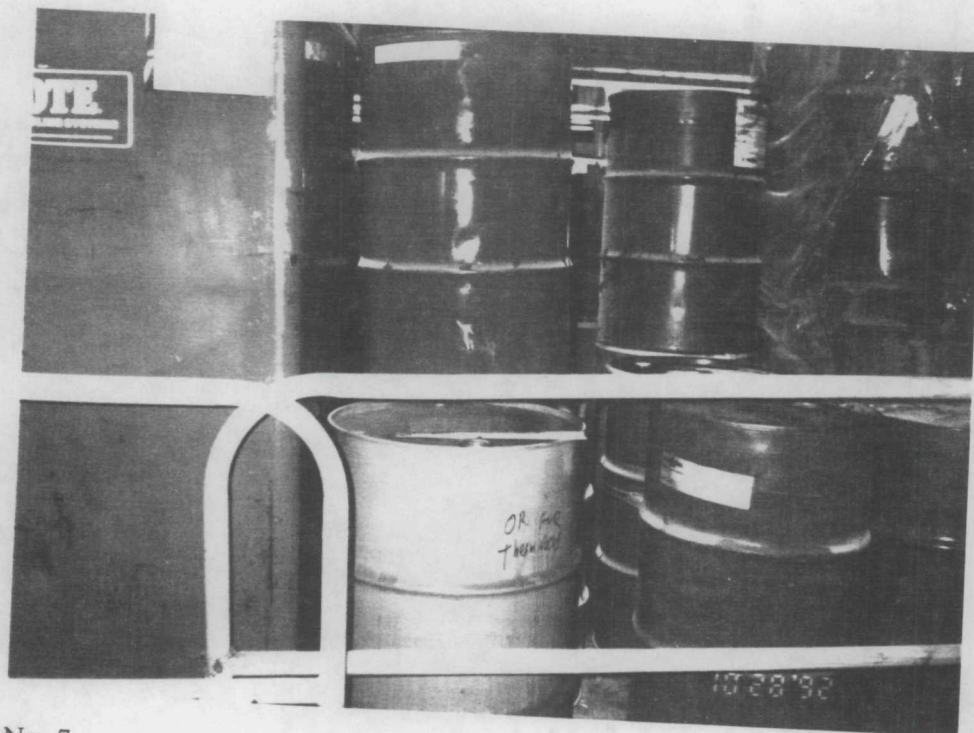
Photograph No. 7

Observations: The unit contained 10 55-gallon steel drums of nonhazardous waste oil during the VSI. No cracks in the concrete floor or visible evidence of spills were observed (see Photograph No. 7).

Recommendations: PRC recommends no further action for this SWMU at this time.

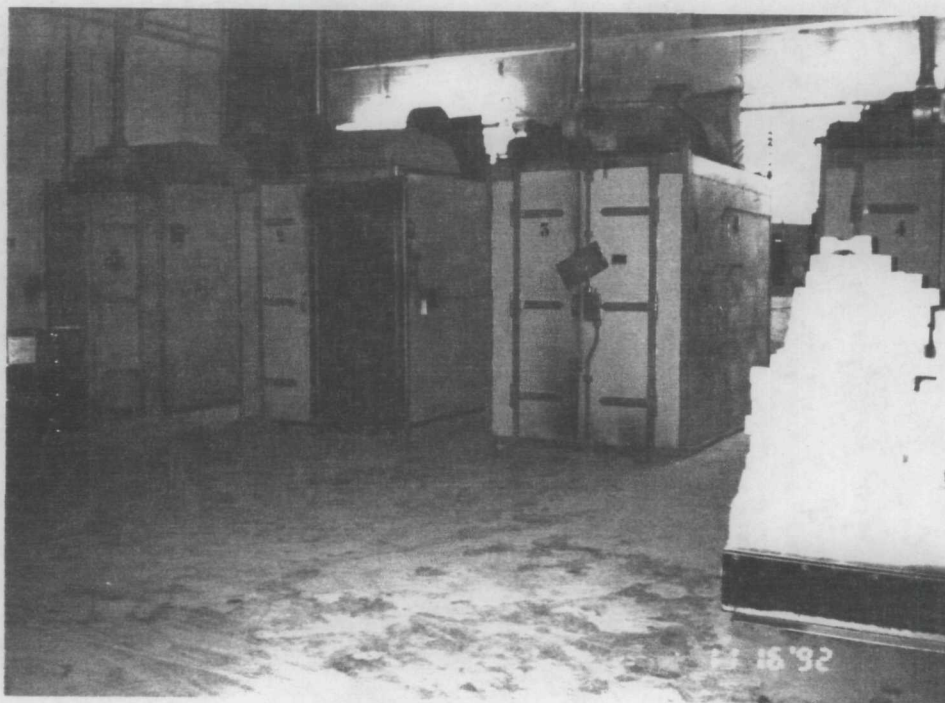
Photograph No. 11
 Orientation: North
 Description: Ovens

Observations: The unit contained no nonhazardous waste during the VSI. No cracks in the concrete floor or visible evidence of spills were observed (see Photograph No. 11).

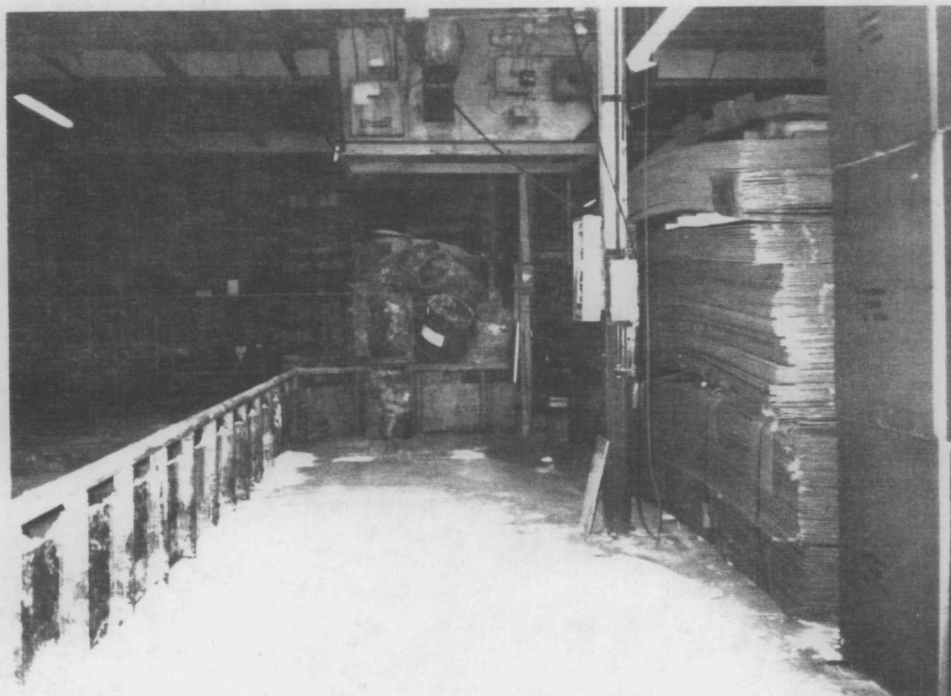
Photograph No. 13

Release Controls:	This unit is located indoors on a concrete floor. No floor drains were visible during the VSI.
History of Documented Releases:	No releases from this unit have been documented.
Observations:	The unit contained one 55-gallon drum of nonhazardous diatomaceous earth during the VSI. No cracks in the concrete floor were observed. PRC observed small amounts of nonhazardous waste on the concrete floor (see Photograph No. 13).

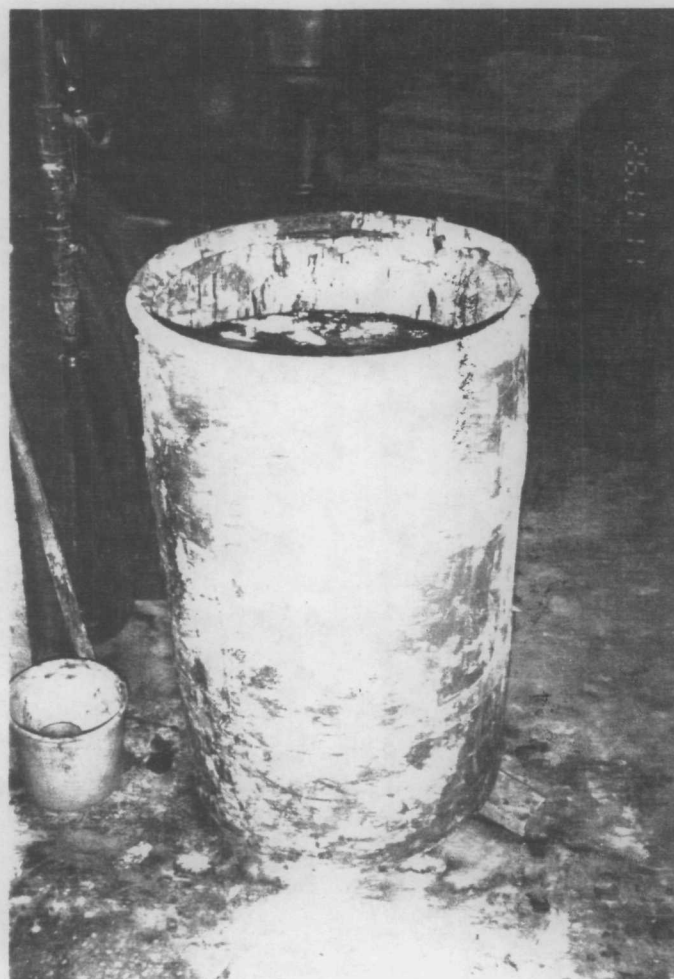
Photograph No. 14

Observations: The unit contained about 45 gallons of nonhazardous diatomaceous earth during the VSI. No cracks in the concrete floor were observed. PRC observed small amounts of nonhazardous waste on the concrete floor (see Photograph No. 14).

Description: Diatomaceous Earth SAA

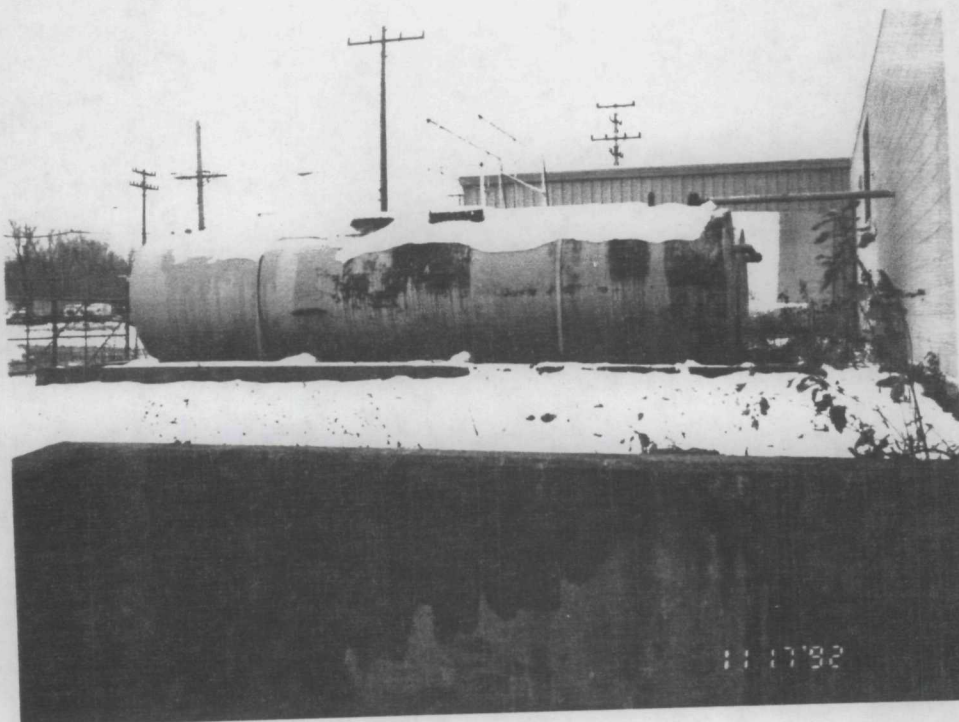
Photograph No. 15
 Orientation: South
 Description: Waste Oil ASTs

Observations: PRC could not observe if the unit contained waste. No cracks in the concrete pad or visible evidence of spills were observed (see Photograph No. 15).

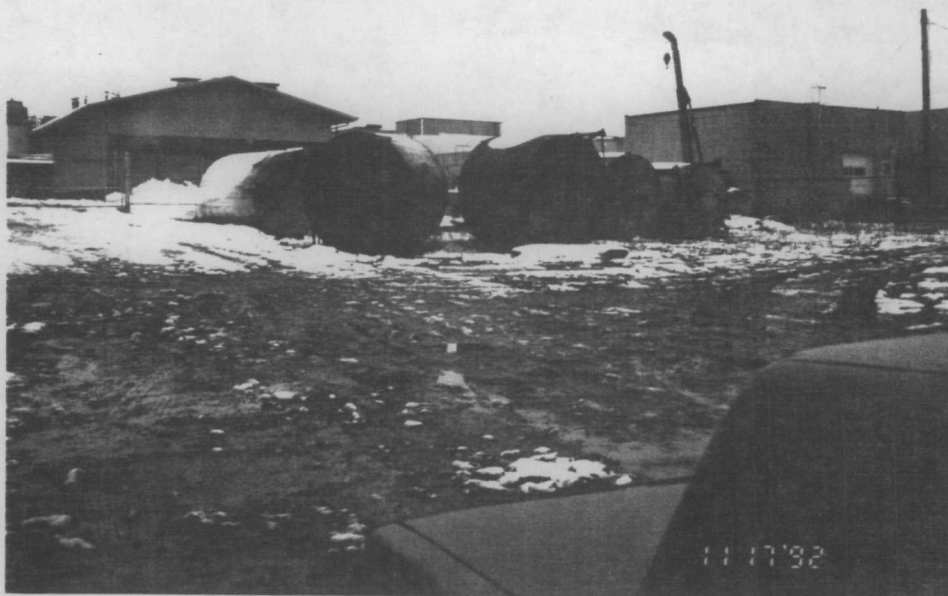
Photograph No. 19
 Orientation: Northeast
 Description: Five 2,500-Gallon Paint ASTs lying on their sides

This AOC is outdoors on soil and northwest of Plant No. 3. Mr. Morrison owns this property. It consists of five 2,500-gallon ASTs constructed of steel. The AOC managed product paint for manufacturing operations. It is not known if the 2,500-gallon ASTs are empty. The AOC began operation in the early 1970s. This AOC has been inactive since 1984. The AOC had no release controls. The AOC did not have secondary containment. No releases from this AOC have been documented. The soils in the area were not stained. PRC noted that the ASTs were lying on their sides (see Photograph No. 19).

PRC recommends further investigation of the Underground Waste Oil Trap (SWMU 14) to determine if the pipes leading to the unit are sealed and the source of an oily sheen noted on the surface of the water found in the unit. AOC 1 consists of two 750-gallon ASTs that contained product solvent. PRC recommends that the facility should determine if the one AST (AOC 1) is empty and that the other AST (AOC 1) does not contain hazardous constituents. PRC also recommends that the facility should determine if the 2,500-Gallon Paint ASTs (AOC 2) are empty or if the ASTs contain hazardous constituents. PRC recommends that the liquid in the Solvent USTs (AOC 3) and soil in the area should be sampled and analyzed for hazardous constituents. PRC also recommends that the facility remove and properly dispose of the Solvent USTs (AOC 3).

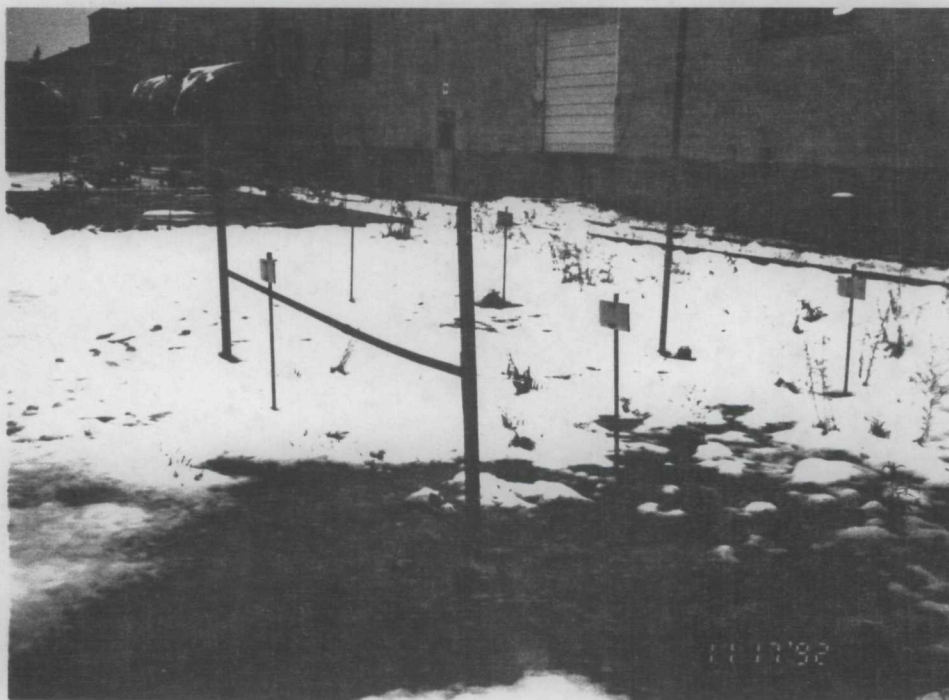
Photograph No. 20
 Orientation: East
 Description: The location of two 1,000-gallon Solvent USTs

This AOC is outdoors and north of Plant No. 1. Mr. Morrison owns this property. According to Mr. Morrison, the AOC consists of two 1,000-gallon USTs constructed of steel. The AOC managed product solvents for manufacturing operations. The USTs began operation in the early 1970s. The USTs have been inactive since 1984. These USTs had no release controls. No releases from the USTs have been documented. Vegetation in the area did not appear to be stressed. According to Mr. Joseph Estock of CM, the AOC currently contains water. The USTs are about 20 years old. The USTs could still contain hazardous constituents from the storage of product solvents. According to Mr. Morrison, the USTs have no secondary containment and have not had integrity assessments conducted (see Photograph No. 20).
